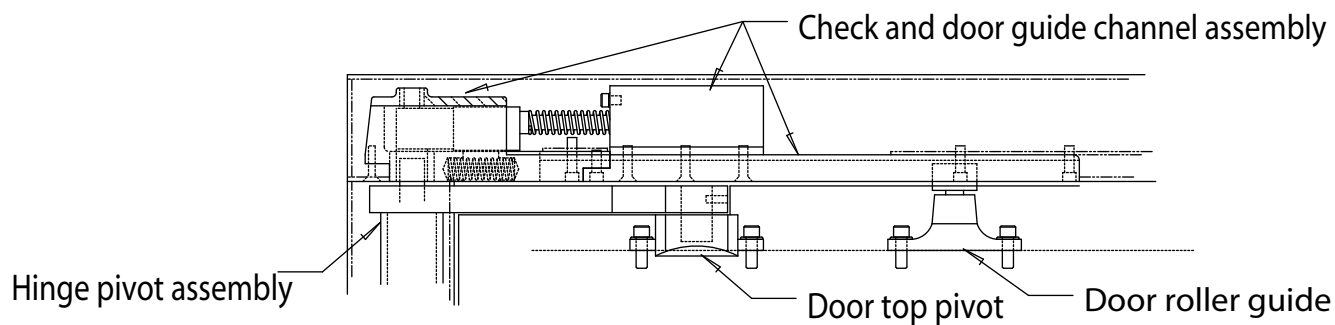
Partial elevation detail "A" showing check and guide channel assembly along with door in the closed position  
(face of door and frame omitted for clarity of hardware)

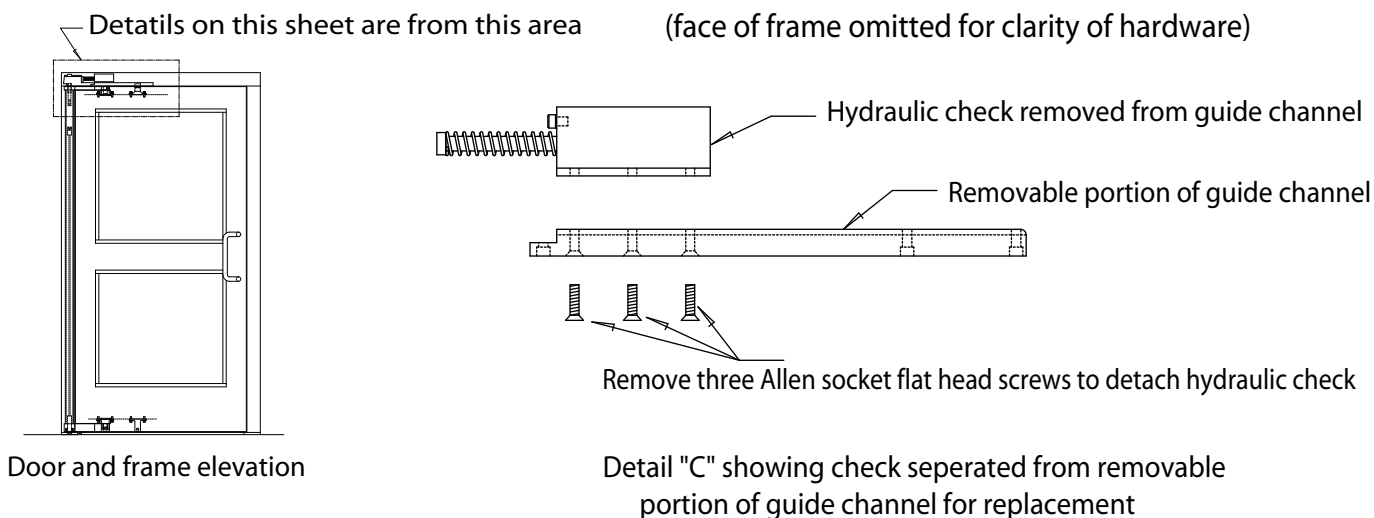
Partial elevation detail "B" showing check and removable portion of guide channel being removed from header while door is in hold-open position
